December 1, 2016

Jonathan and Bobby Harmison 607 Maple Street Overbrook, Kansas TCS #2016.048

Per your request an inspection of the basement support columns was performed on Tuesday November 29, 2016. The following conditions were observed.

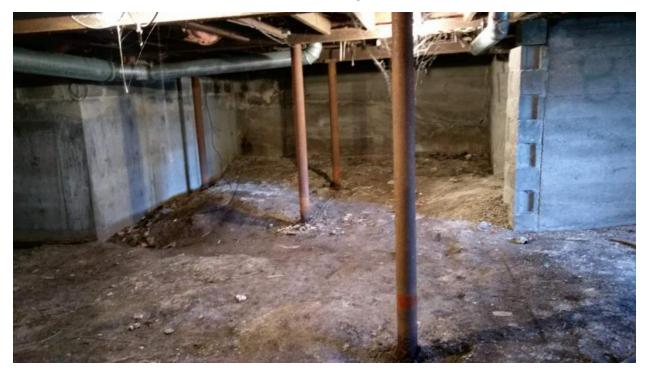
East Area (Looking East)

The basement is separated into two areas, the west area has a concrete floor and the east area has an ungraded gravel floor. The basement columns in the west area have the concrete around them. The basement columns in the east area have the gravel around them. All of the columns have signs of rust at the base; some of the columns have failed due to the rust.
