TCS #2017.011

Re: Laura Eddy
1883 N Road
Emporia, Kansas

Per your request an inspection of a Factory Built Unit was performed on Wednesday July 26, 2017. The unit was damaged during shipment from the manufacturer's facility to the client's property. Per the transportation company a bridge was hit in Oklahoma.

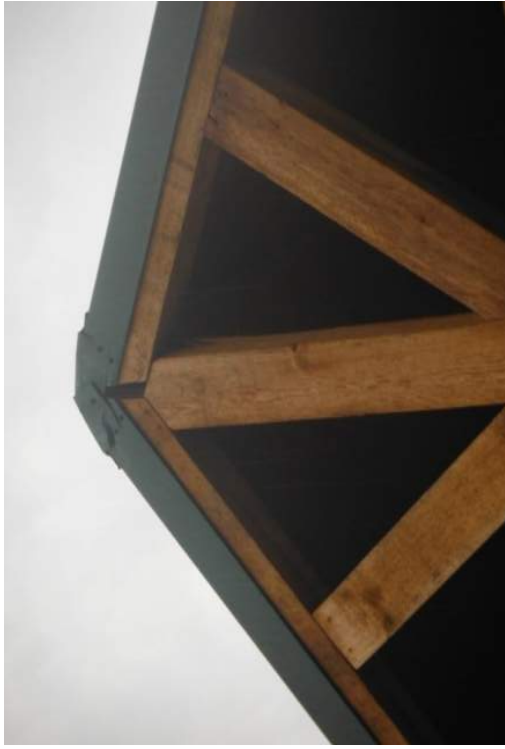
Photo #1

1. Timber members at the deck roof are separated from the timber ridge member (Photo #1)
2. Column supporting the header of the deck roof is cracked (Photo #2)

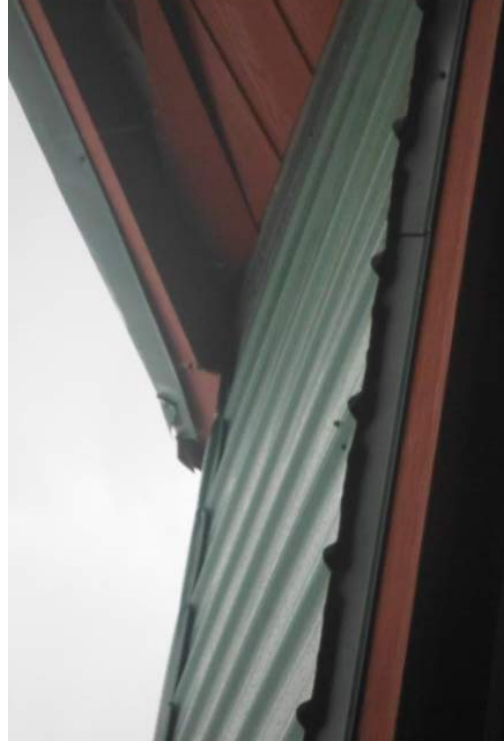
Photo #3

3. Half column at exterior wall is separated from the wall (Photo #85)
4. Loose and missing siding at the end wall above the deck roof (Photo #3, #4)
5. Loose and missing siding at the end wall below the rake of the roof (Photo #5, #6)

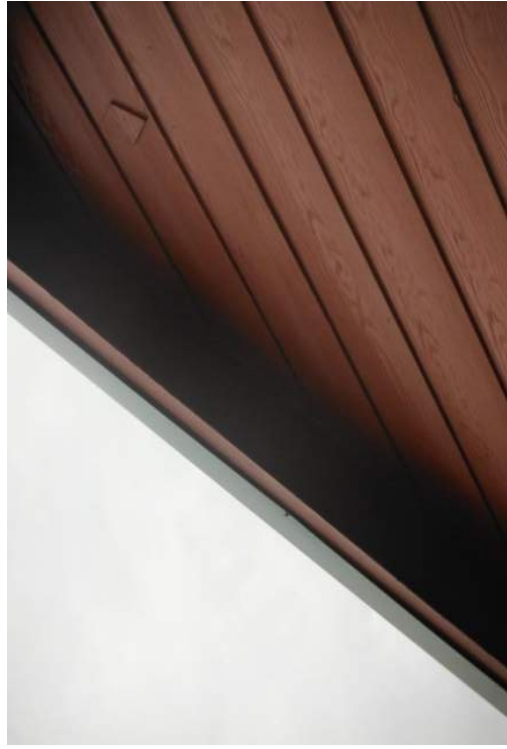
Photo #13

8. Metal roofing deformation along the north eave (Photo #10, #11, #12)
9. Exposed unfinished siding under the rake at the east end wall (Photo #13, #15)

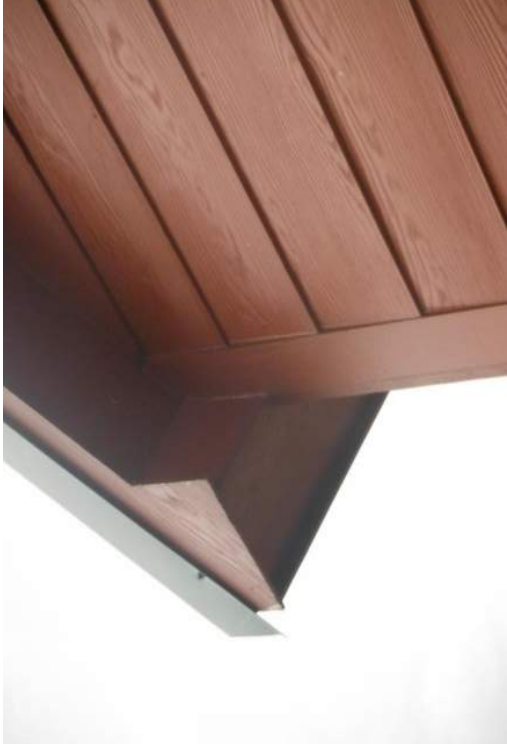
Photo #14

10. Exposed unfinished siding under the overhang east end wall (Photo #14, #16)
11. Deformation of the ridge cap and rake trim east end wall (Photo #17)

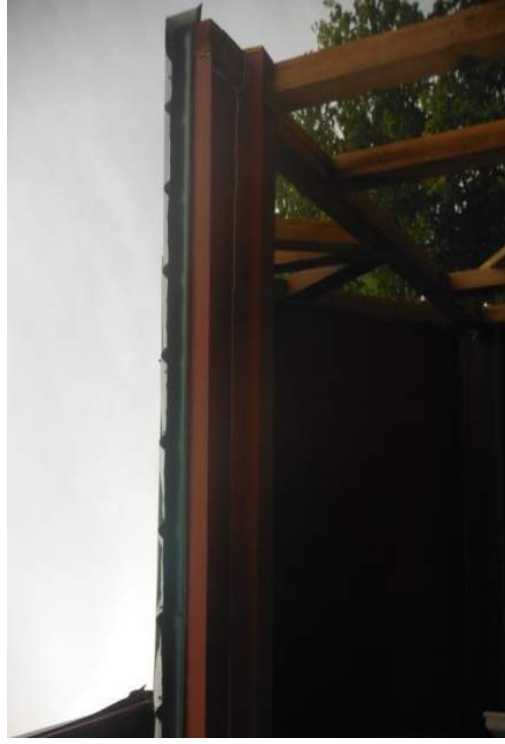
Photo #18

12. Exposed unfinished siding under the south eave of the deck roof (Photo #18, #19, #20)
13. Half column at exterior wall is separated from the wall and damaged at the top, additional nails were added (Photo #22)

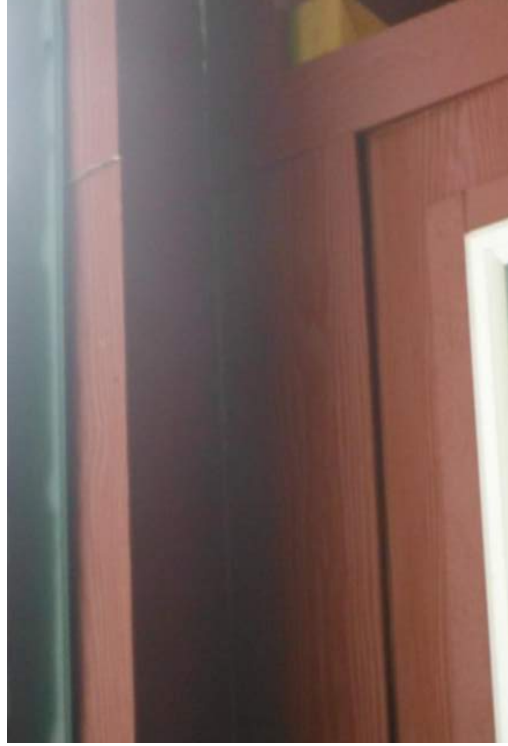
Photo #21

14. Exposed unfinished siding under the south eave of the deck roof (Photo #22)
15. Soffit and fascia material crack at the south east exterior corner (Photo #21, #22)

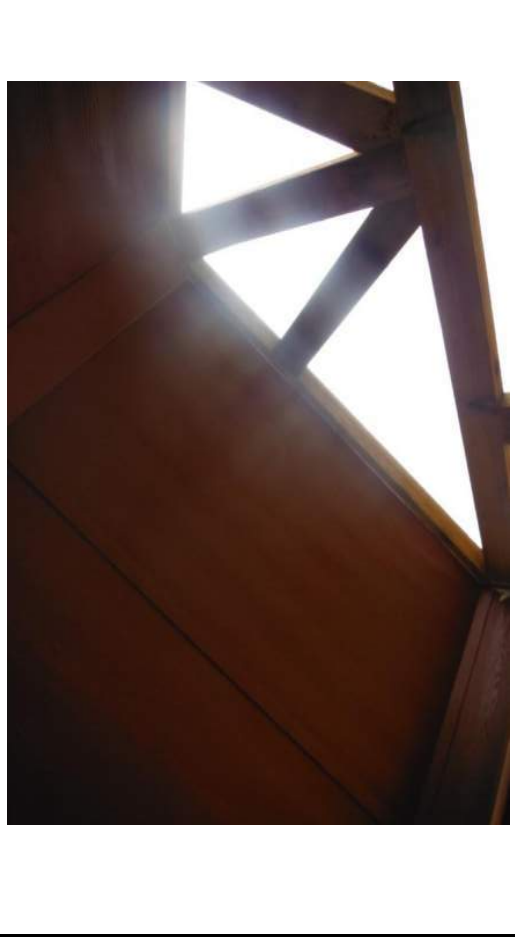
Photo #24

16. Paint line exposed at the ceiling material along the timber beams at the end of the deck roof (Photo #24)
17. Exposed unfinished deck ceiling material, ridge trim piece is loose (Photo #25, #26)

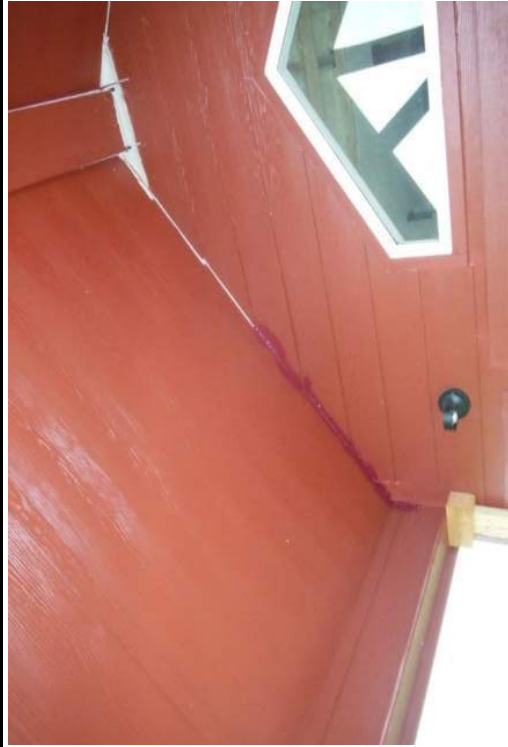
Photo #27

18. Exposed unfinished siding under the deck ceiling at the end wall (Photo #27, #28)
19. Exposed unfinished siding under the eave along the north wall (Photo #29, #31)

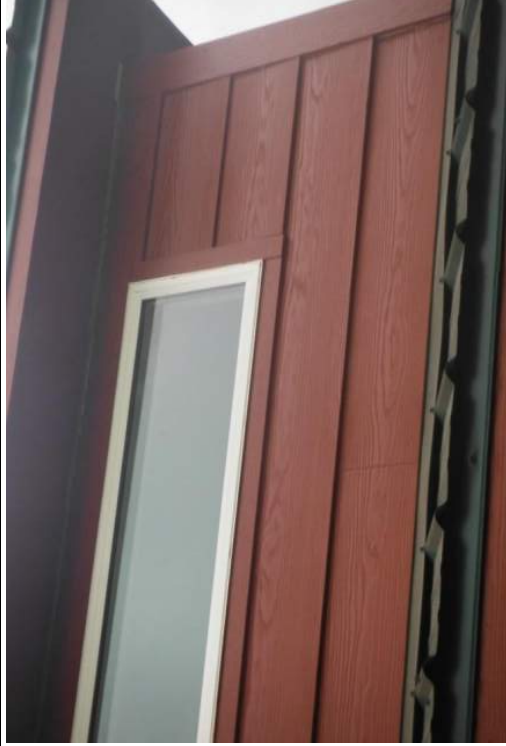
Photo #33

22. Siding damaged at the west side of the box outs on the north side (Photo #30, #32)
23. Exposed unfinished siding under the eave along the south wall (Photo #33, #34, #35, #36, #37, #87)

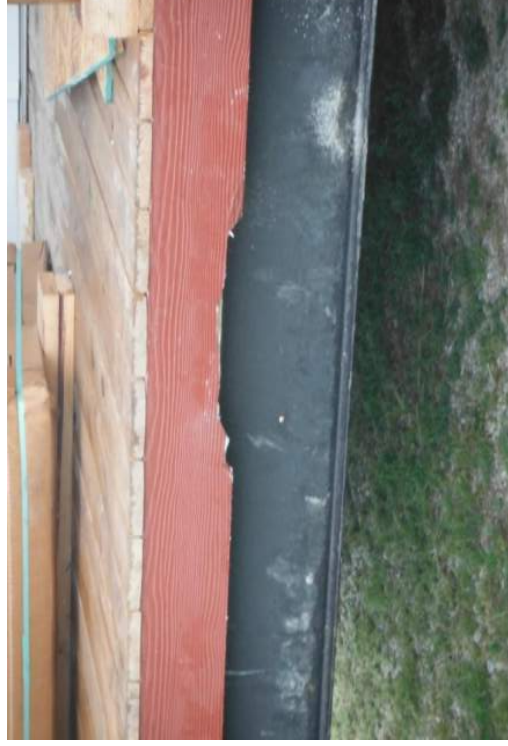
Photo #38

24. Exposed unfinished trim at the southwest corner (Photo #88)
25. Band board at the end of the deck is damaged (Photo #38)
26. Diagonal crack in siding from corner of window south wall (Photo #39)

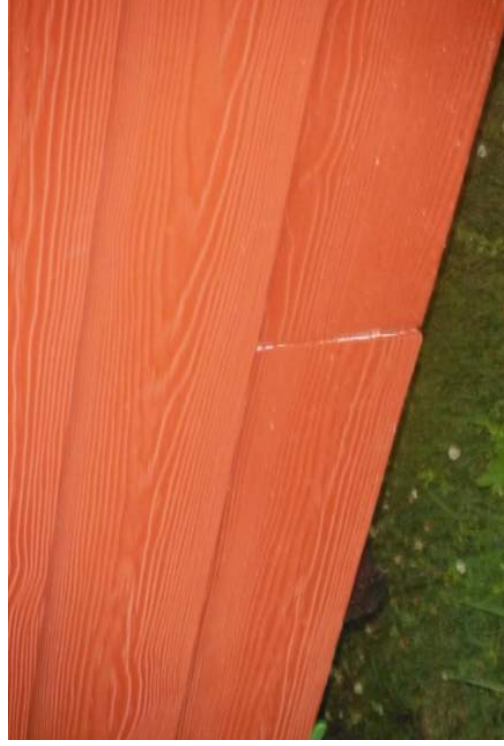
Photo #40

27. Siding joints that have separated on the south wall (Photo #40, #41, #42, #43, #44)

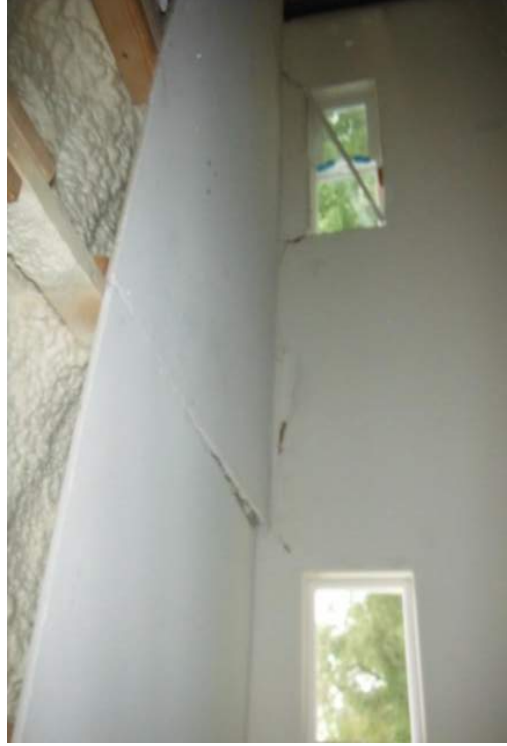
Photo #65

28. Drywall corner cracks throughout (Photo #45, #46, #47, #59, #60, #63, #64, #89, #90, #91)
29. Horizontal and vertical drywall cracks (Photo #50)
30. Drywall (diagonal) cracks at corners of windows numerous location (Photo #49, #51, #52, #53, #53, #55, #56, #57, #58, #61, #62)
31. Drywall damage at the loft windows (Photo #65, #66, #67, #68, #78)

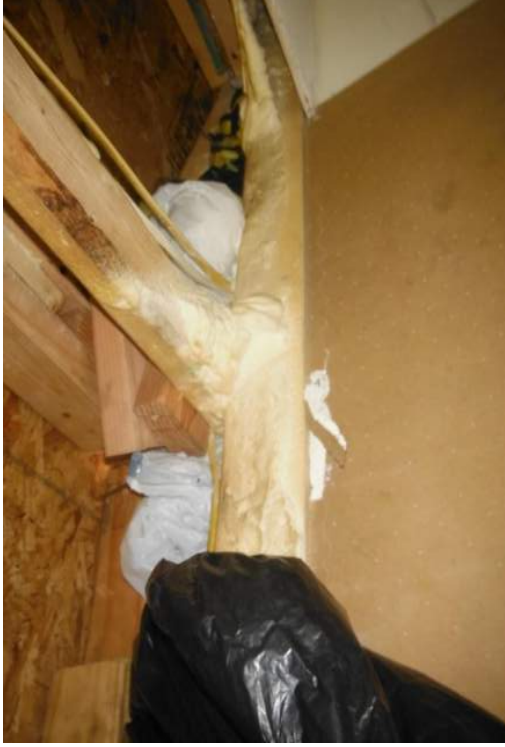
Photo #69

37. Ridge board cracked at the west end (Photo #69, #70)
38. Numerous ceiling joist are cracked (splice blocks installed) (Photo #71, #72, #73, #74, #95)
39. Roof sheathing replaced at the east end wall (Photo #75, #76)

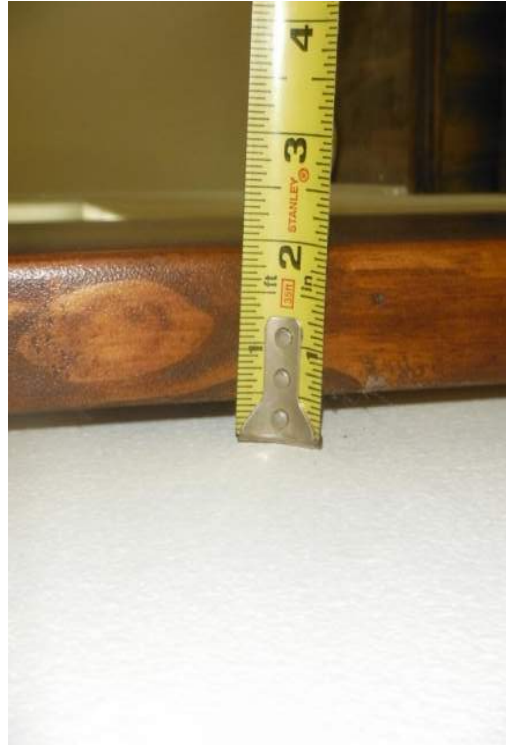
Photo #79

32. Guardrail termination trim is separated from the wall (Photo #78, #79, #80, #92, #93, #94)
33. Damaged wall cabinet (Photo #81)
34. Loft floor is covered with drywall dust (Photo #82)
35. Kitchen ceiling finish is been damaged (Photo #83)
36. First floor is covered with drywall dust (Photo #84)

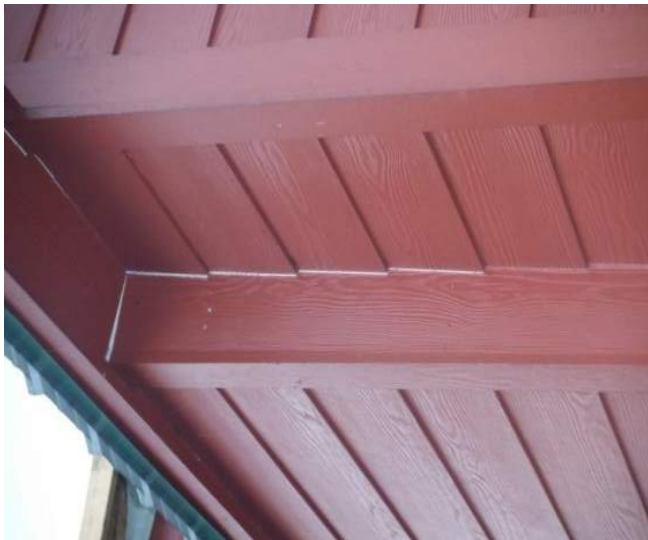
Photo #86

20. Exposed unfinished siding at the box out at the bedroom (Photo #29, #31, #86)
21. Exposed unfinished siding at the box out at the bathroom (Photo #31)
