TCS #2017.011

Re: Laura Eddy
1883 N Road
Emporia, Kansas

Per your request an inspection of a Factory Built Unit was performed on Wednesday July 26, 2017. The unit was damaged during shipment from the manufacturer's facility to the client's property. Per the transportation company a bridge was hit in Oklahoma.

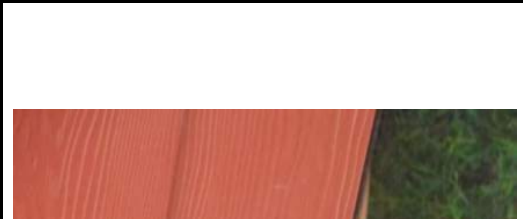
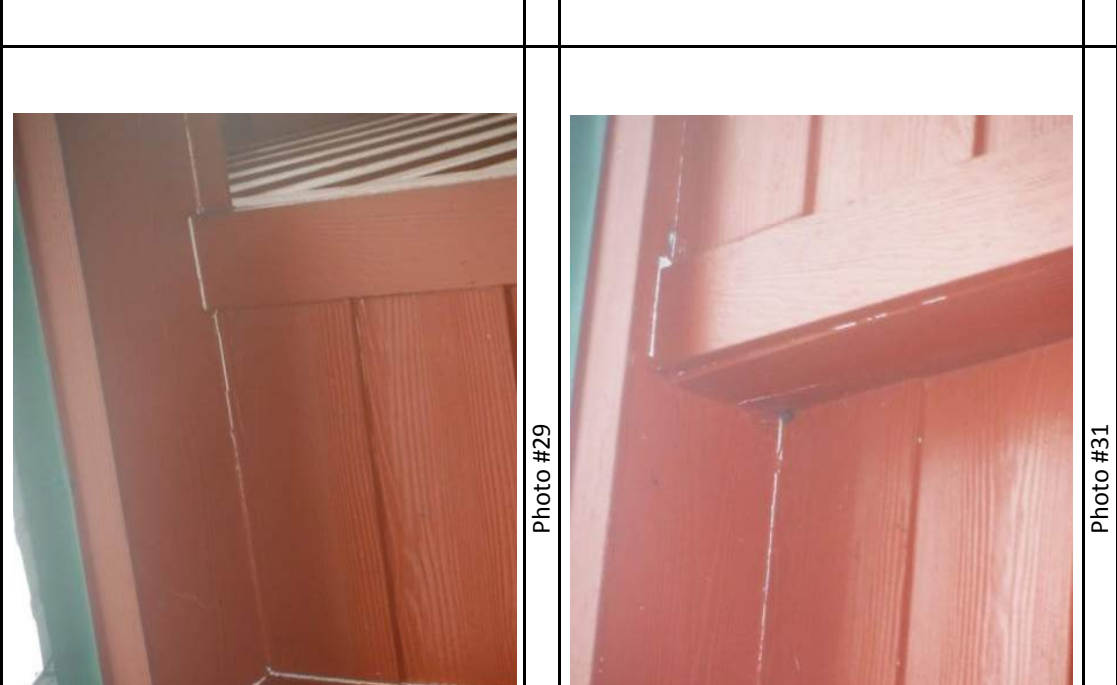
Photo #29		Photo #30					
Photo #31		Photo #32

18. Exposed unfinished siding under the deck ceiling at the end wall (Photo #27, #28)
19. Exposed unfinished siding under the eave along the north wall (Photo #29, #31)

20. Exposed unfinished siding at the box out at the bedroom (Photo #29, #31, #86)
21. Exposed unfinished siding at the box out at the bathroom (Photo #31)

22. Siding damaged at the west side of the box outs on the north side (Photo #30, #32)
23. Exposed unfinished siding under the eave along the south wall (Photo #33, #34, #35, #36, #37, #87)
